U.S. 101 MP 102.97 Unnamed Tributary to Big Creek (WDFW ID 990033): Preliminary Hydraulic Design Report

U.S. 101 MP 102.97 Unnamed Tributary
Preliminary Hydraulic Design Report
January 2022

The proposed project will replace the existing 43-inch (in) (rise) by 73-inch (span), corrugated metal pipe arch, measuring 96 feet in length, with a structure designed to accommodate a minimum hydraulic opening of 24 feet. A specific structure type will be determined by others during future phases of the design. The proposed structure is designed to meet the requirements of the federal injunction using the unconfined bridge design criteria as described in the 2013 WDFW *Water Crossing Design Guidelines* (WCDG) (Barnard et al. 2013). This design also follows the WSDOT *Hydraulics Manual* (WSDOT 2019) with supplemental analyses as noted.

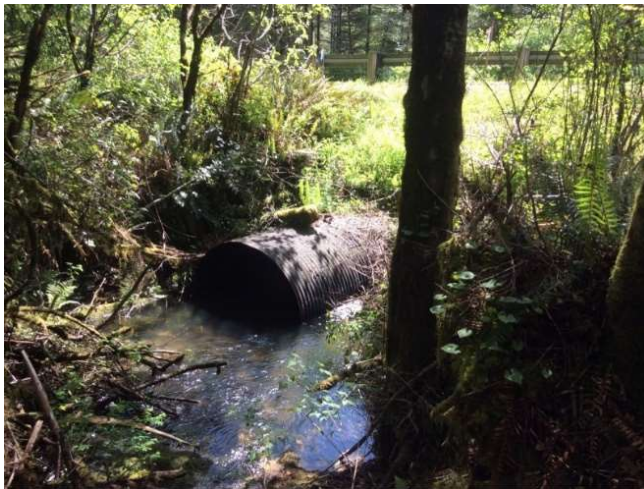
Figure 6: Culvert inlet

The existing structure is a 96-~~feet~~-long, approximately 43-inch-tall by 73-inch-wide corrugated metal pipe arch culvert with a gradient of approximately 0.1 percent. It is ~~inferred~~ from the ~~surrounding~~ topography that the original channel was straightened when the culvert was installed by shortcutting a relic channel meander (see Section 2.8.2). The inlet is situated below a hardpan grade control that forms a steep step below a much lower gradient segment of channel upstream (Figure 6). The outlet of the culvert is directed at a roughly 3 to 4 feet high vertical right bank (Figure 7), which curves sharply to the left within approximately 10 feet of the downstream end, indicating that high flow velocities exiting the culvert are insufficient to erode the underlying hardpan. This suggested low energy during flooding is consistent with observations of fine sediment accumulations above hardpan grade controls (see next section). There was some racking of debris at the downstream end of the culvert outlet scour pool.

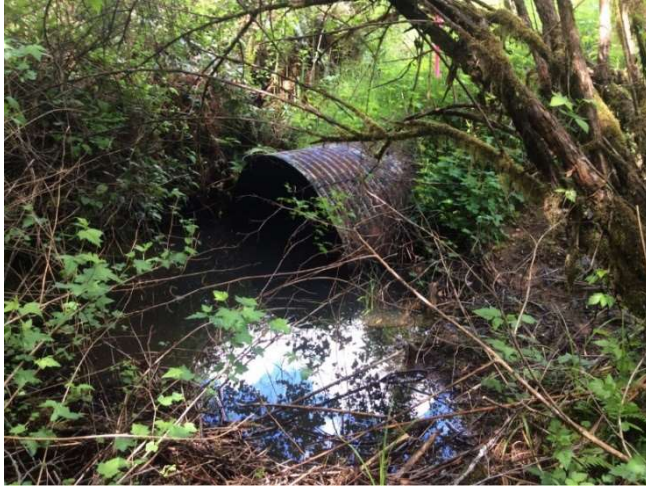
Figure 7: Culvert outlet

It appears the steep gradient (4 percent) between the grade control and the culvert has remained fairly stable over time (Figures 7 and 20). There were no clear field indicators of incision/degradation of the channel at the grade control, even though the channel appears to have been excavated for routing flows to the present US 101 culvert, as evidenced by the dead-end channel split to the right at the grade control. This inference is supported by high floodplain connectivity of the channel upstream of the grade control feature. This grade control appears to help to maintain wetlands and off-channel habitat.

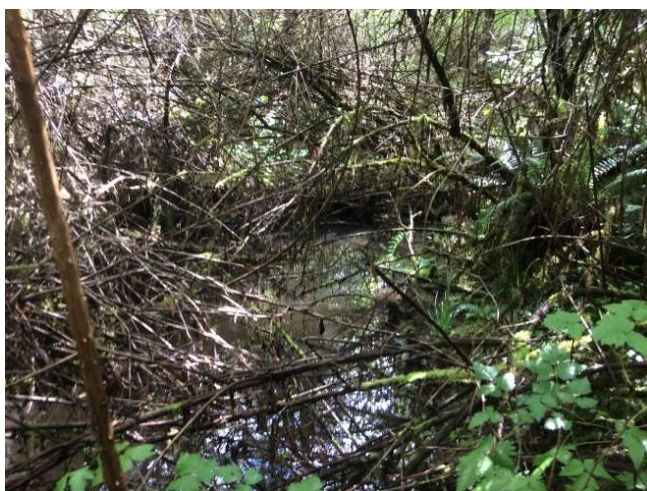
Figure 12: Racked debris

The channel upstream and downstream of the culvert is variably blocked by large wood material (LWM) and racked up accumulations of woody and vegetative debris caught up on LWM and snags along the banks (Figure 12). There were three obstructions observed downstream of the culvert that are suspected to influence hydraulics at the road crossing, that block between approximately 25-35 percent of the bankfull flow area. At some locations logs span the channel (Figure 13), and elsewhere there are large stumps and logs partially or wholly submerged in the water (Figure 14).

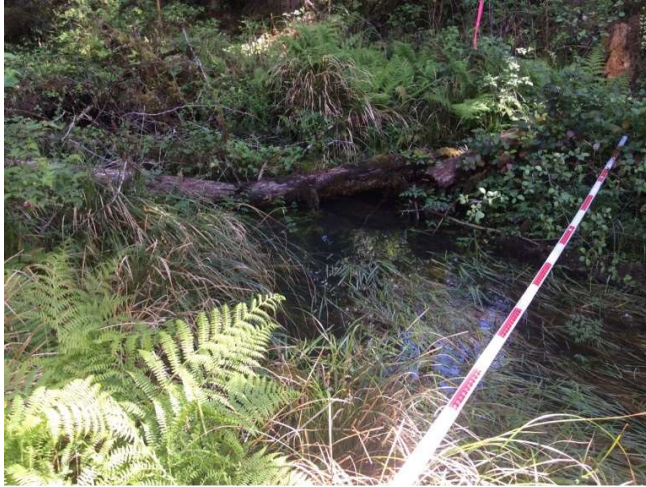
Figure 13: LWM across channel

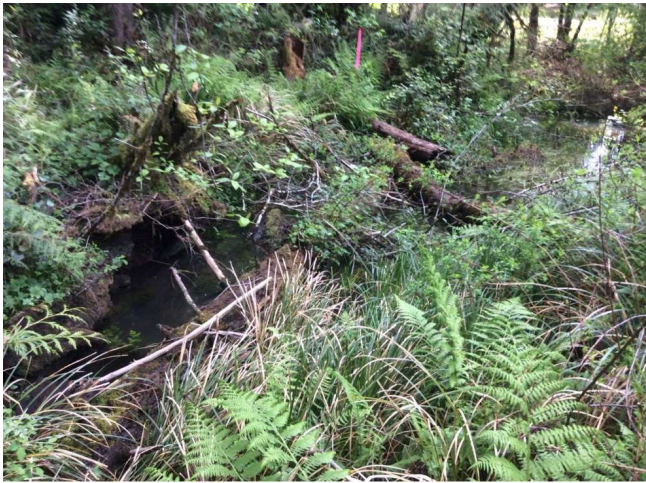
Figure 14: LWM along channel banks

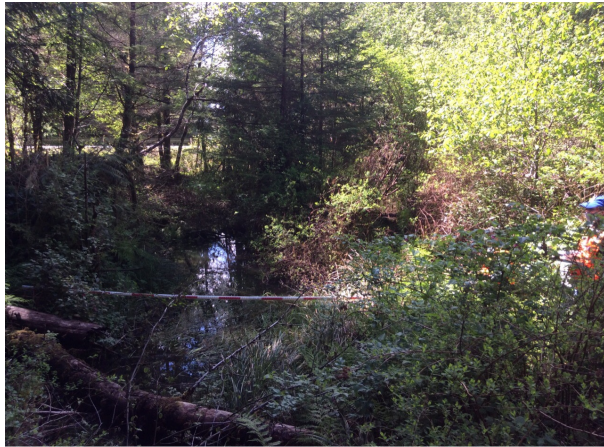
Figure 15: Upstream Reference Reach 1, looking downstream towards U.S. 101

Two relatively straight sections of stream were chosen as reference reaches, situated approximately 70 feet upstream of the culvert (Reference Reach 1; Figure 15) and 250 feet downstream of the culvert (Reference Reach 2; Figure 16). They were considered representative of the different instream and floodplain hydraulic and geomorphic characteristics observed upstream and downstream of the culvert (Figure 17). The upstream reach is influenced hydraulically and geomorphically by a hardpan grade control upstream of the culvert, and by backwater from the culvert. The downstream reach is representative of natural conditions with abundant instream and floodplain roughness, and intermittent

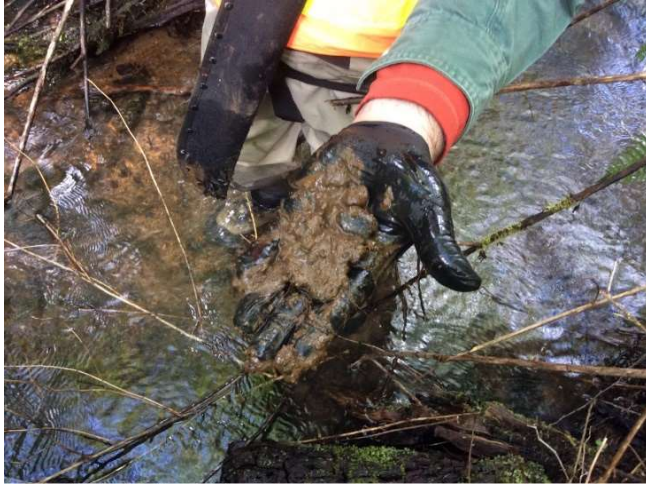
Figure 19: Example of streambed material

Field observations and the land cover data indicate there are lower gradient wetlands upstream of the crossing that likely limit sediment transport and thus supply rates to the project site (Section 2.1). Field observations noted that the grade control at Station 29+25 upstream of the culvert currently limits the transport of coarse bed material downstream. Mobile sediments appear to consist of mostly fines, although there are some patches of small gravel (Figure 19). A bulk surface sample was collected from a heavily embedded gravel patch on a hydraulic control downstream of the culvert (cf. Figure 16), dried, sieved, and weighed. The sample grain size distribution is summarized in Table 4. This grain size distribution is comparable to that found in the nearby stream under crossing 991501, which also drains through glacial outwash, and thus appears to be a characteristic gravel size for the basin.

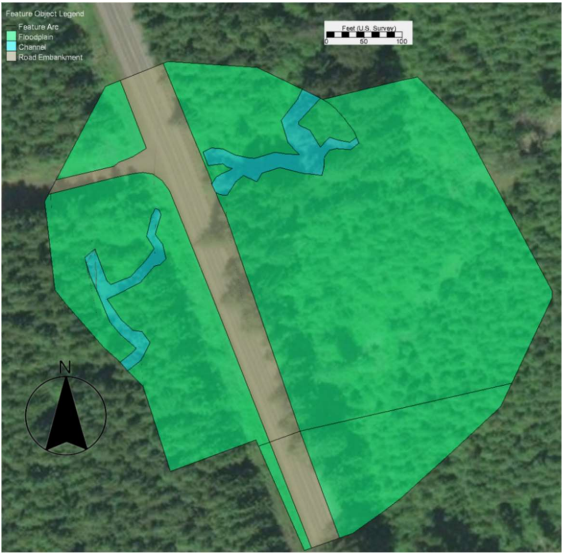
Figure 25: Spatial distribution of roughness values in SRH-2D existing-conditions model

Table 7: Manning’s n hydraulic roughness coefficient values used in the SRH-2D model

Land cover type	Manning’s n
Stream Channel	0.101
<u>Within Proposed Crossing</u>	<u>0.041</u>
Floodplains	0.112
Roadway	0.02

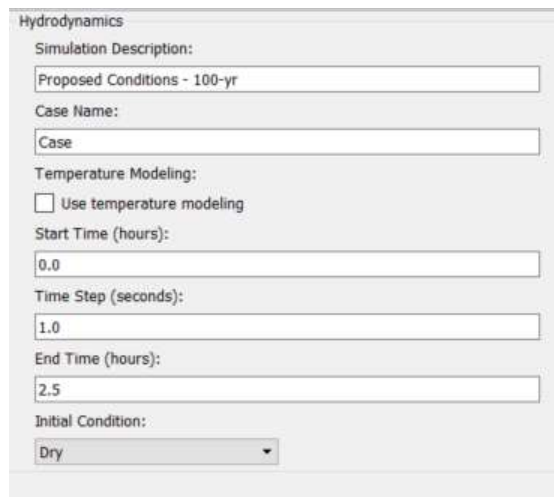
Figure 36: Model controls with dry initial conditions

ensure flow continuity between upstream and downstream. Figure 36 depicts the model controls for all other runs, which used a simulation time of 2.5 hours. The result output frequency used was once per minute (0.016 hour) to begin with to troubleshoot the model, and graduated to every 15 minutes (0.25 hour) once the model was stable.
